# Lancair 235/320/360 Main Gear Over-Center Link Design Improvement

Chris Zavatson, 7-1-2024

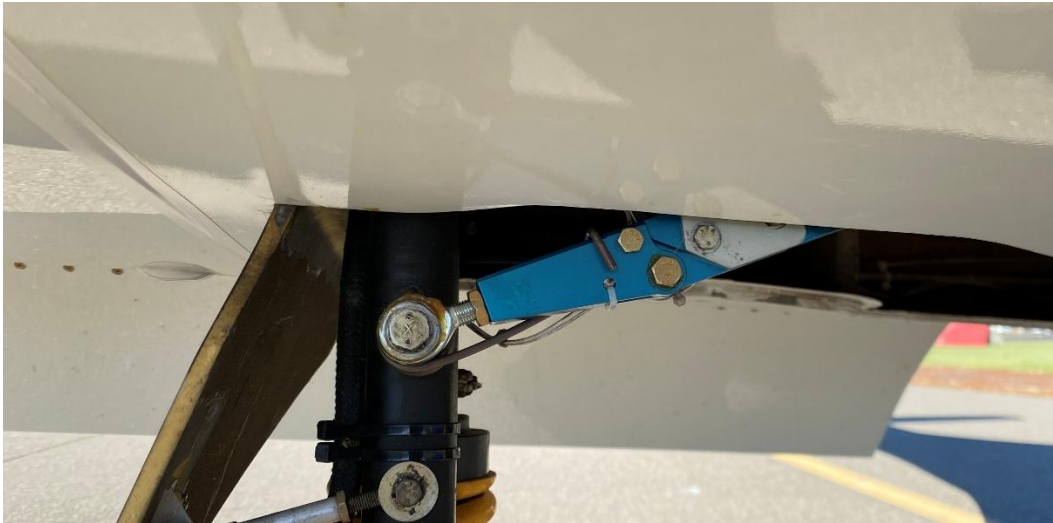
*Figure 1, The Main Gear Over-Center Link on a Lancair 360*

I am always on the look-out for long term wear issues in our planes. One system I closely examine every annual is the over-center link on the main landing gear. I remove the parts, disassemble, clean, and measure the hole dimensions and the resulting play in the joint. For some 22 years wear stayed down around .001". One year wear jumped to .003 unexpectedly. The bearing surfaces have never run dry so perhaps some sort of fine abrasive was introduced in the prior year. Whatever the cause, there are a few weaknesses in the original design. The first is that the bearing material is the aluminum part itself. This makes the link a wear item. The second thing I noticed during the prior annual is that one of the press fit bearings had loosened. I had seen this on other planes. Below are photos taken by one very lucky owner. The bearing had loosened and the link slipped off. It was just hanging on to the bolt head. Note: This installation is supposed to have a large washer under the bolt head to prevent disassembly in the event of a loose bearing.

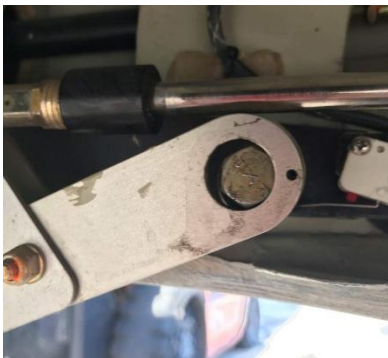
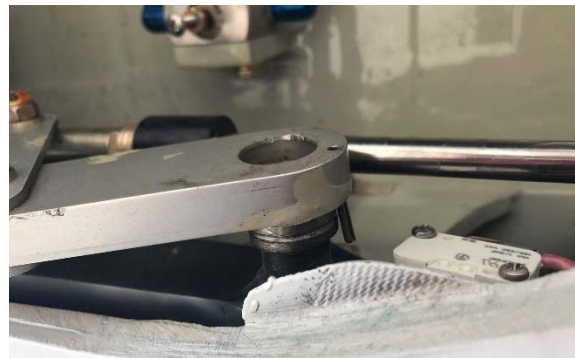
*Figure 2, An Over-Center link that slipped off the bearing*

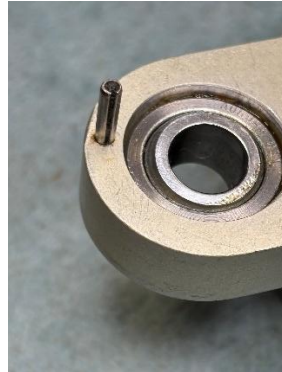
*Figure 3, The roll pin hole greatly reduces the local material cross-section*

One theory that could explain the loosening of the interference fit on the bearing over time involves the very small cross section produced when the hole for the roll pin is drilled. If the remaining cross section yields (stretches) in the slightest it will loosen the grip on the bearing. For this size bearing the interference is approximately 0.001". The hoop stress is substantial and the material cross section up against the bearing is only .049" thick in the stock part.

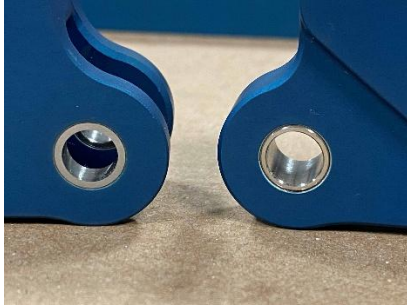
*Figure 5, High strength bearings installed in new Over-Center Links*

New Over-Center links were fabricated to accommodate the three small journal bearings. While the new links are made of a stronger 7075 aluminum alloy, a slight bump out was added so that the bushing volume would not reduce the material cross section. Similarly, material was added where the roll pin hole is drilled to maintain the same nominal material cross section.

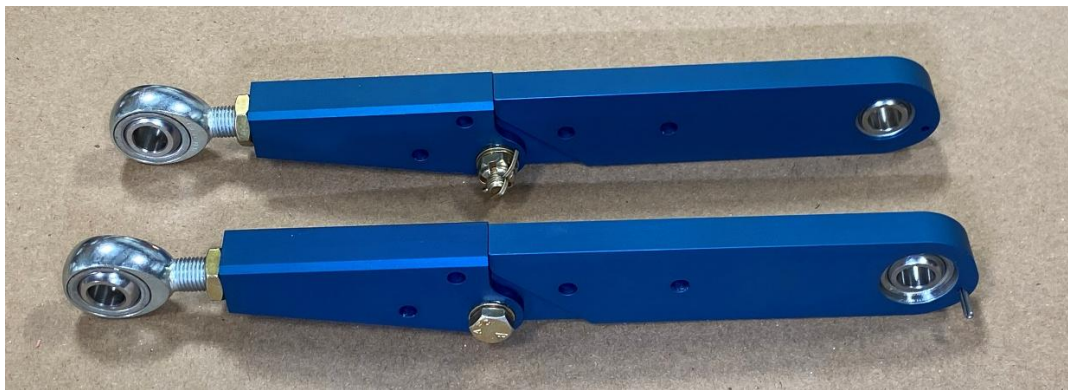
*Figure 7, Complete Set of new Over-Center Links*

This new design approach both reduces free-play in the joint and extends the life of the part indefinitely. The wear item is now an inexpensive AN bolt.
